Re: Seven Hills Lake Dam

**CONTRACT EE-DSGN3
Small Dams Contract Development**

**Assessment Report for
Seven Hills Lake Dam
Eastern Operations Division
NYSDEC ID# 213-2531**

October 2011

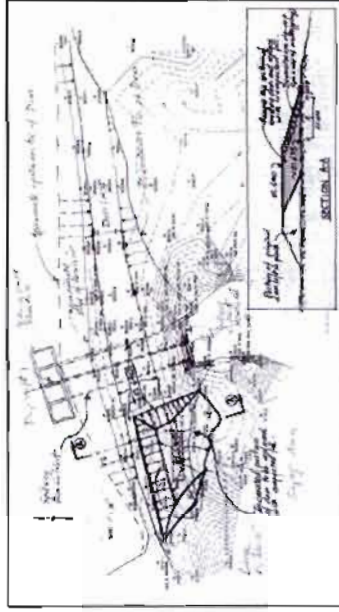
Seven Hills Dam – Reconstruction of Right Abutment Portion of the Dam

Some seepage was observed at the downstream toe of the dam, in the area to the right of the spillway discharge culvert; this area needs to be repaired. The stability analyses undertaken for this assessment show that the Seven Hills Lake Dam would be stable if the proposed modifications are implemented.

- Remove upstream portion of right abutment down to foundation level
- Reconstruct dam with compacted fill
- Add rip-rap slope protection at downstream slope to protect against minor overtopping
- Low Level Outlet
- Lower reservoir using existing sluice gates and pumps as necessary
- Remove existing sluice gates and frames at drop inlet structure
- Install new stainless steel sluice gates and frames

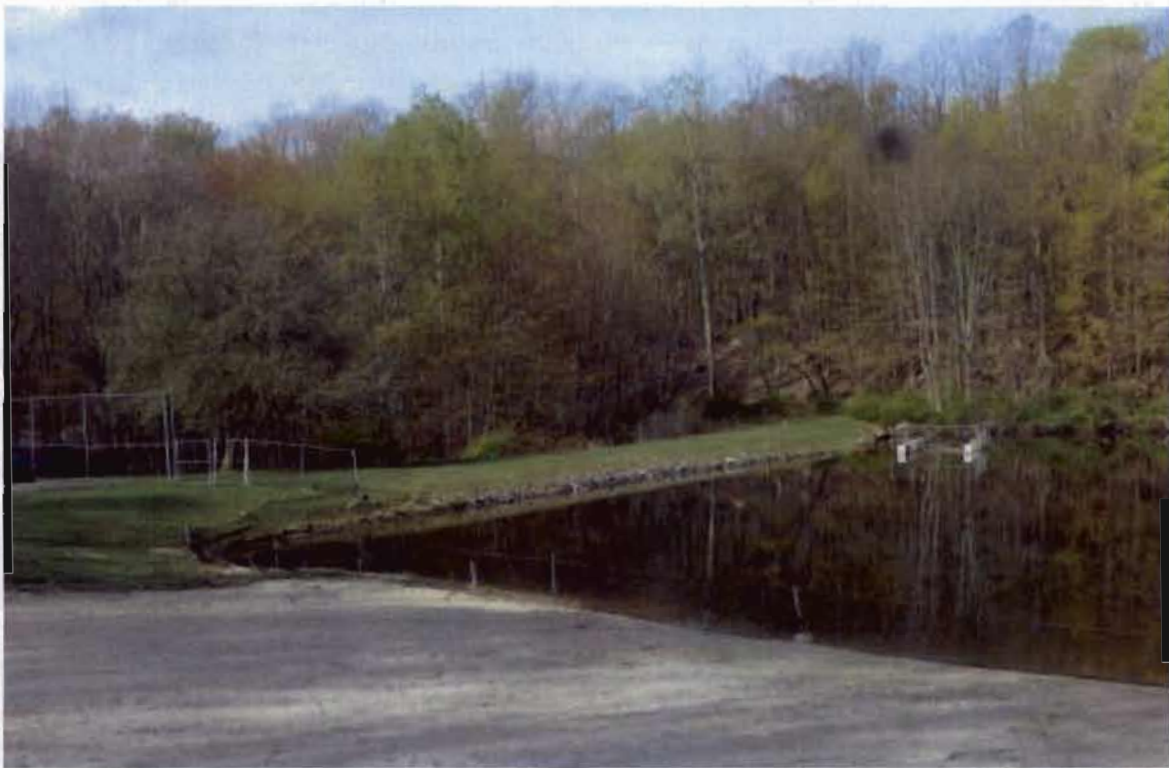
Figure 2-2: View of Seven Hills Dam

The Seven Hills Lake Dam is a 240-foot long earth embankment with a crest width that varies between 16 and 18 feet (See Figure 2-2). The embankment is in generally good condition, except for about 30 feet of the downstream embankment slope near the right abutment, which is in poor condition. The upper reaches of the upstream slope are grassed and the remainder of the slope to lake level and below is protected with dumped stone riprap. The downstream embankment slope on the left side of the service spillway is covered with grass and is in good condition. There is moderate erosion along the lower area of the slope abutting the downstream left spillway training wall.

The downstream slope on the right side of the service spillway is not well maintained and is overgrown with trees, bushes, saplings, cattails, and grass. There is moderate erosion along the lower area of the slope abutting the downstream right spillway training wall.

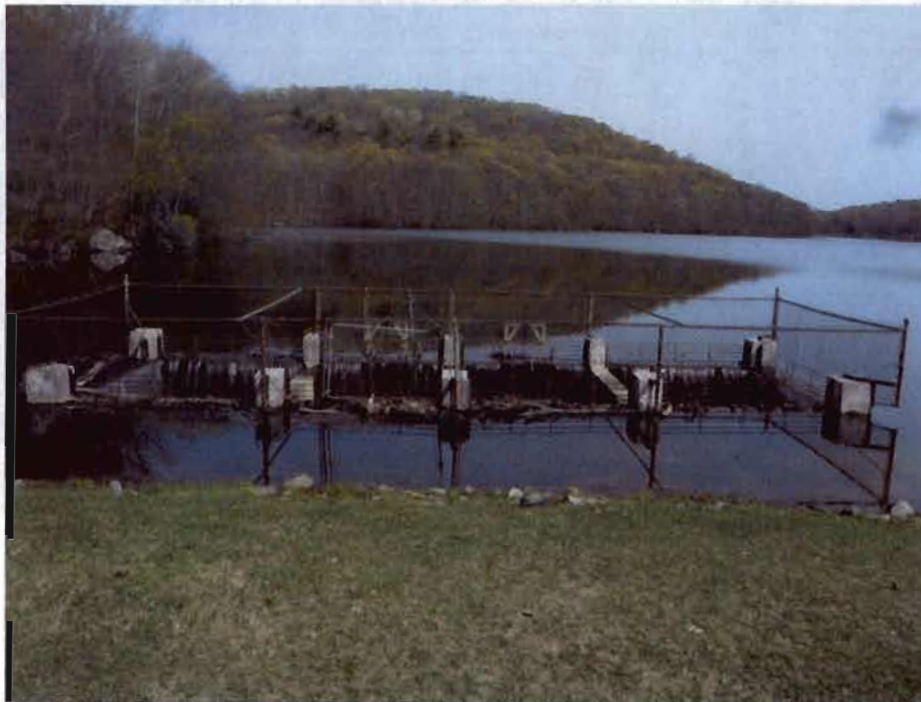
Figure 2-3: Seven Hills Dam - Drop Inlet Spillway

The low level outlet of the dam is combined with the drop inlet service spillway. There are two openings 24" diameter, with sluice gates located at the bottom of the upstream face of the concrete intake structure; these gates serve as the upstream intake of the low level outlet. The operating gate stems of both sluice gates are located at the top of the structure. The operating stem of the right low level outlet sluice gate is out of alignment by about 10 degrees from the vertical.

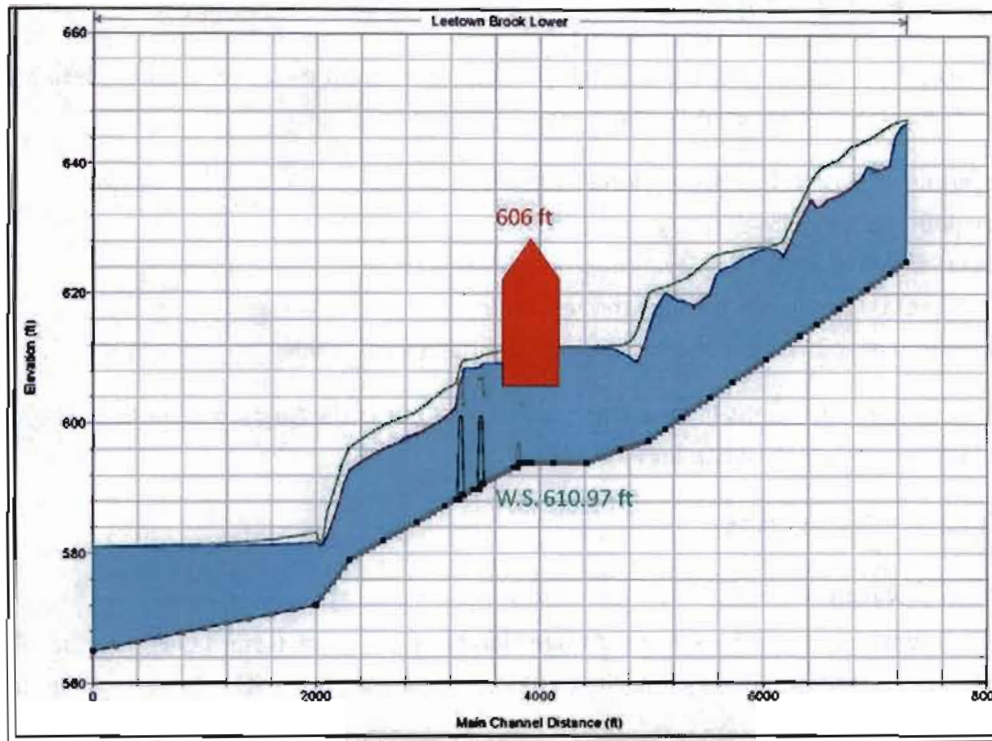
Figure 3-7: Downstream Profile during SDF Dam Break at Seven Hills Lake Dam

It should be noted from Figure 3-7 that the SDF Dam Break at Seven Hills Lake Dam would cause significant flooding at the Frank Pond residence, as well as significant flooding at the downstream bridges.

Based on the present study, the house located at Frank Pond Dam would experience significant flooding in the event of a dam break during the Spillway Design Flood at Seven Hills Lake Dam. It is therefore confirmed that the Seven Hills Dam should remain as Hazard Class B.

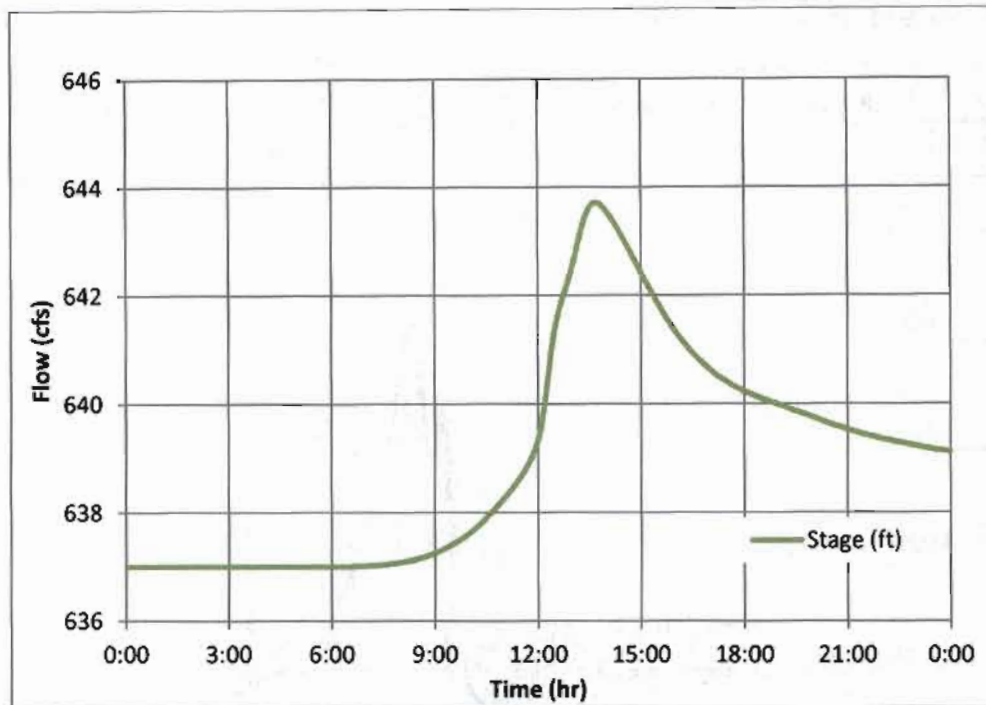
Figure 4-3: Seven Hills Lake Dam – Reservoir Stage during SDF Event

- 150% of 100-yr, 24hour storm:
 - Peak Outflow: 6,820cfs
 - Maximum Water Surface Elev.: 643.7 ft

The Seven Hills Lake Dam has been classified by NYSDEC as a Hazard Class B dam. The Spillway Design Flood for this dam is 150% of the 100-year flood. During the Spillway Design Flood (SDF) event, the reservoir is estimated to reach a peak stage 3.7 feet above the top of dam, and the total outflow is estimated at 6,820 cfs. Only about 1,950 cfs of this total would be passed by the drop inlet spillway, with a flow of about 4,870 cfs passing over the crest of the dam. This indicates clearly that the capacity of the existing spillway is significantly inadequate.

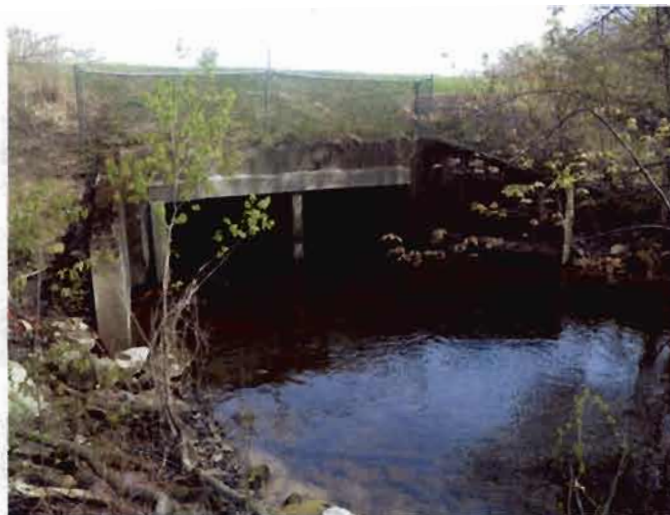
Figure 5-1: Reservoir Outlet

The low level outlet has an estimated discharge capacity of 120 cfs with the reservoir at normal pool level (spillway crest elevation), and is capable of releasing 90% of the reservoir volume in 1.9 days.

The low level outlet capacity is thus adequate to meet NYSDEC reservoir draw-down criteria.

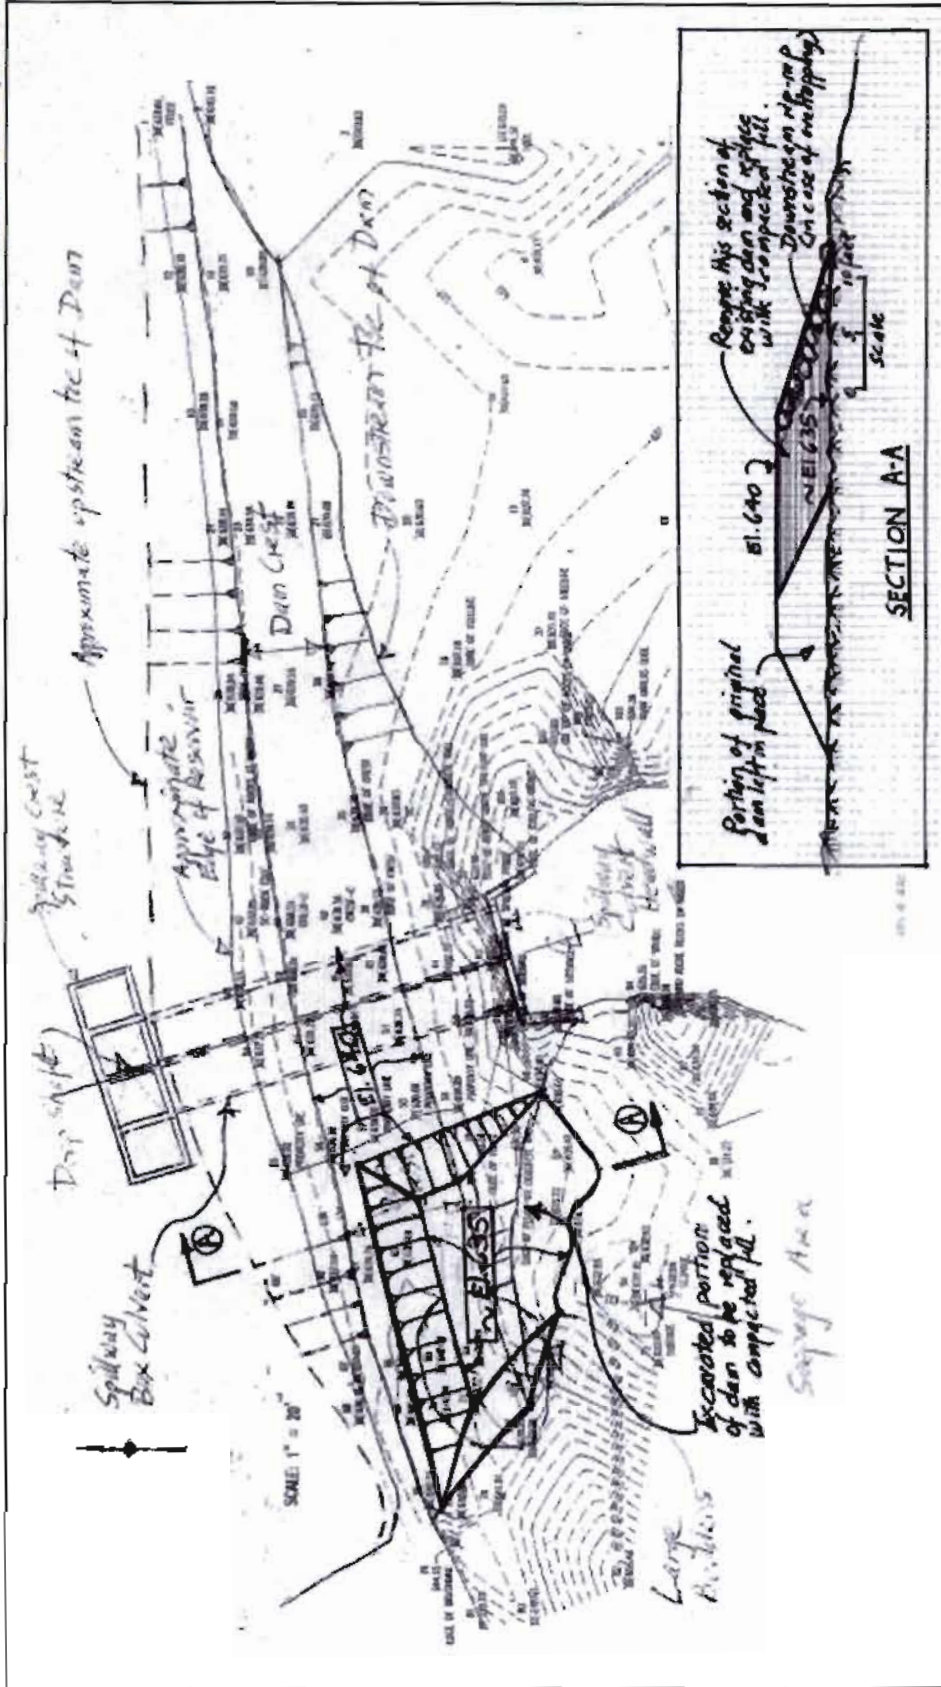
Figure 6-3: Reconstruction of Right Abutment Portion of the Dam

The downstream slope of the portion of Seven Hills Dam to the west of the DEP property line is very irregular and strewn with large rocks. There is also seepage at the toe of this portion of the dam. It is speculated that the dam may have overtopped in this area sometime in the past and has been repaired

with rock fill. It should be noted that the dam is only capable of passing about the 15-year flood without overtopping. The probability of this having occurred during the 50 year life of the project is very high, in the order of 97%.

In this portion of the dam, the crest width is in excess of 20 feet, and the depth of fill is estimated to range from 4 to 8 feet. It is recommended that the downstream shoulder of the dam be removed down to foundation level and replaced with compacted fill as shown schematically on Figure 5-6. Rip-rap should be placed on the downstream face of the reconstructed dam to provide some erosion protection in the event of dam overtopping sometime in the future. If it is decided to proceed with the construction of the ACB Overflow Spillway discussed above, this reconstruction of the right abutment portion of the dam would be a good first step in providing uniform foundation conditions for the ACB mat.
