CONTRACT EE-DSGN3

Small Dams Contract Development Technical Memorandum 2-3 EOH Dam Inspection Reports

Eastern Operations Division:
EOH-07 – Seven Hills Lake Dam

October 2010

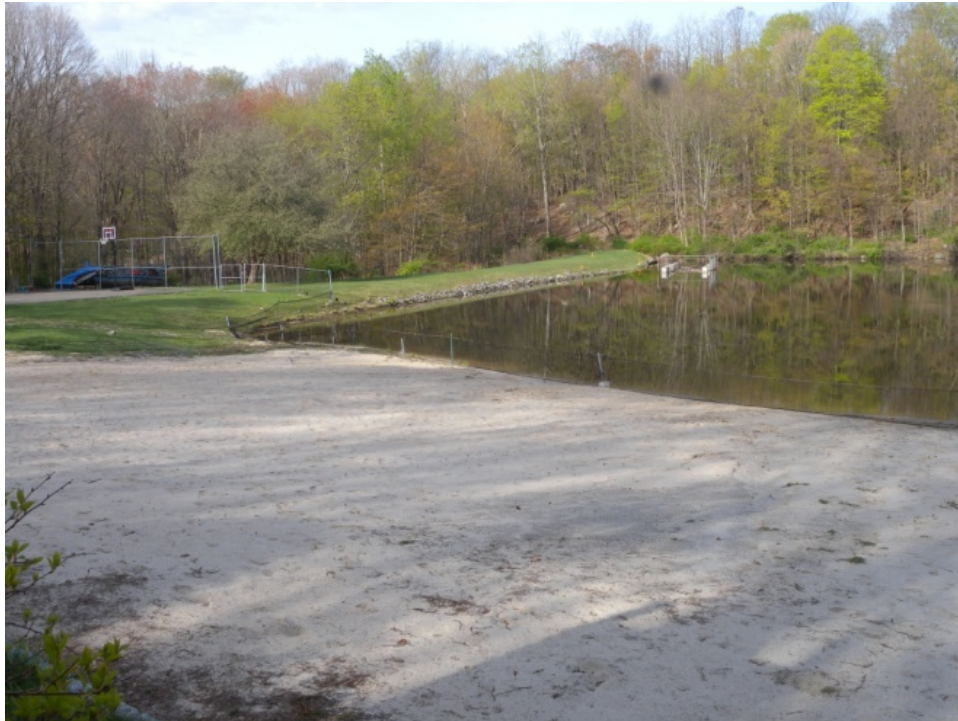
The Seven Hills Lake Dam is a 240-foot long earth embankment with a crest width that varies between 16 and 18 feet (Photo 1). The embankment is in generally good condition, except for about 30 feet of the downstream embankment slope near the right abutment, which is in poor condition. The upper reaches of the upstream slope are grassed and the remainder of the slope to lake level and below is protected with dumped stone riprap (Photo 2). The slope is in generally in good condition except for some grass growing through the riprap stones.

Photo 1 - EOH-07 Lake and Upstream View of Dam

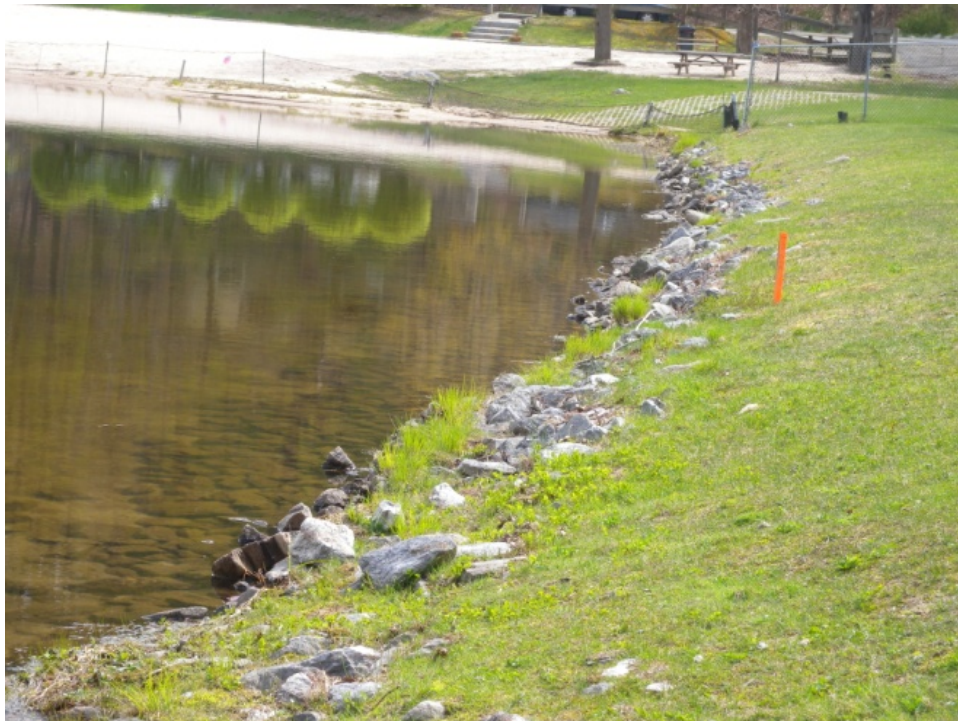
Photo 2 - EOH-07 Upstream Slope

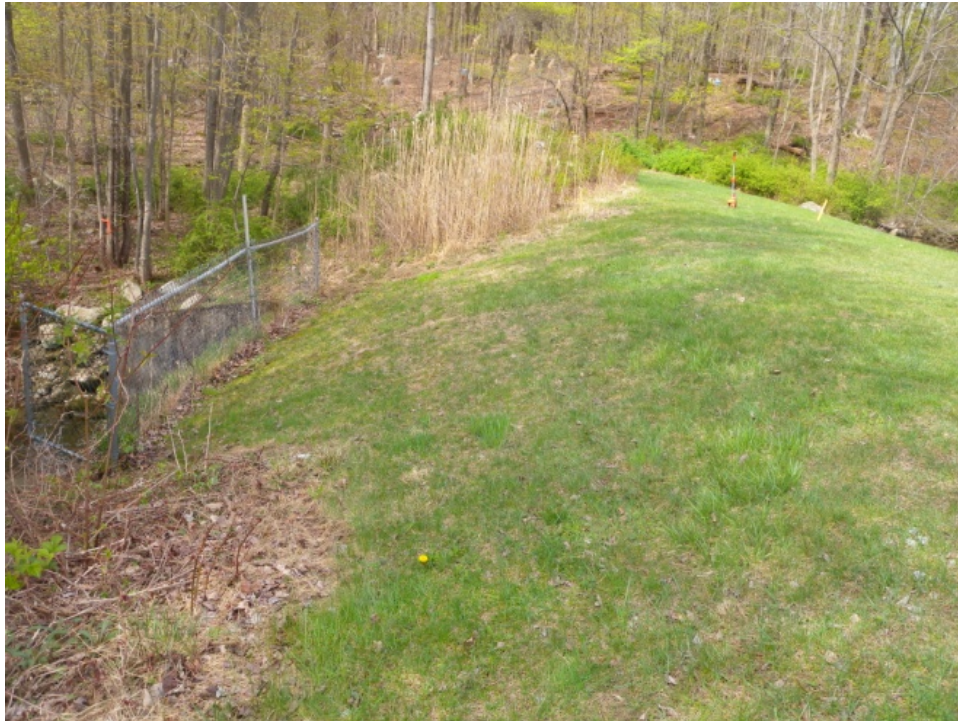
The downstream embankment slope on the left side of the service spillway is covered with grass and is in good condition (Photo 3). There is moderate erosion along the lower area of the slope abutting the downstream left spillway training wall, which is most likely a result of surface runoff. Other than this, there are no other visible signs of sloughing, erosion or cracking.

Photo 3 - EOH-07 Downstream Slope

- a) The eroded areas of the downstream embankment slope abutting both downstream spillway training walls should be restored with compacted backfill and erosion protection.

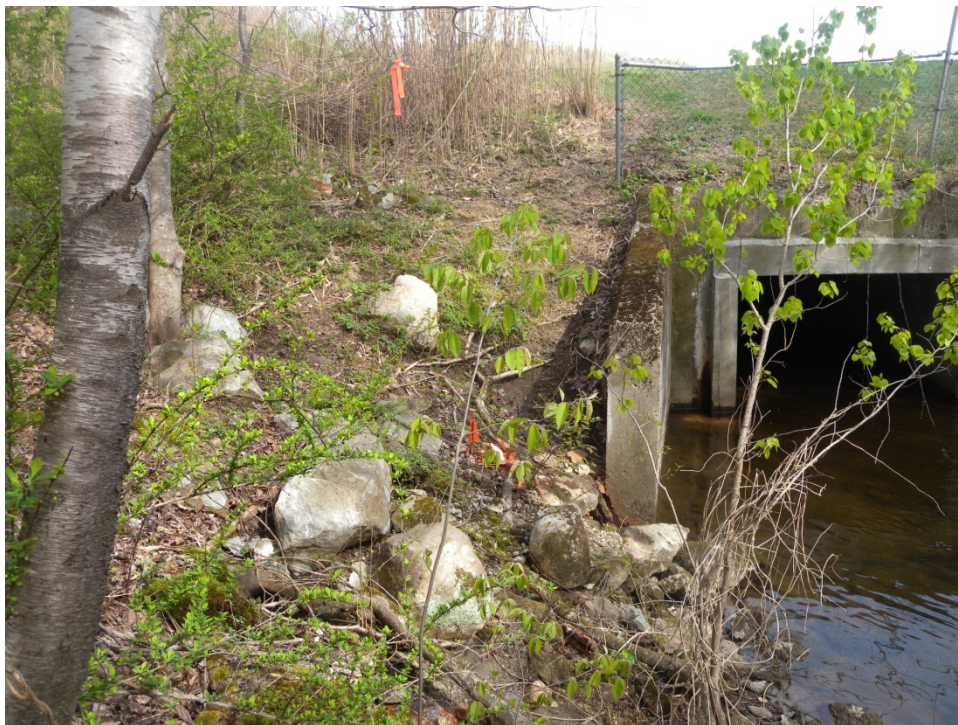
The downstream slope on the right side of the service spillway is not well maintained and is overgrown with trees, bushes, saplings, cattails, and grass. There is moderate erosion along the lower area of the slope abutting the downstream right spillway training wall, which is most likely a result of surface runoff (Photo 4).

Photo 4 - EOH-07 Erosion near the Right Spillway Outlet Training Wall

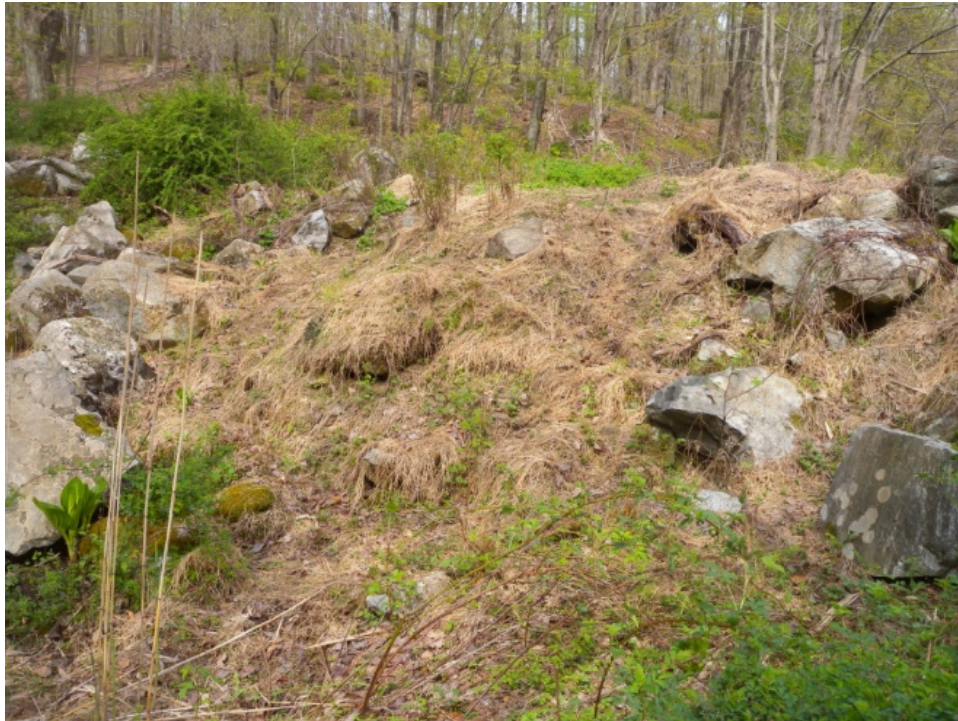
About 30 feet of the downstream slope surface near the right abutment consists of dumped large size boulders and rock fill; additionally, this area is overgrown with grass and bushes (Photo 5). There is significant seepage along the downstream toe of the rock fill, but the exact source of seepage is not clear (Photo 6). The area downstream of the toe is covered with lush vegetative growth.

Photo 5 - EOH-07 Right Abutment Downstream Slope

- b) Heavy brushes, shrubs, saplings, and other vegetative debris should be removed from the right side of the downstream embankment crest edge and the downstream slope.

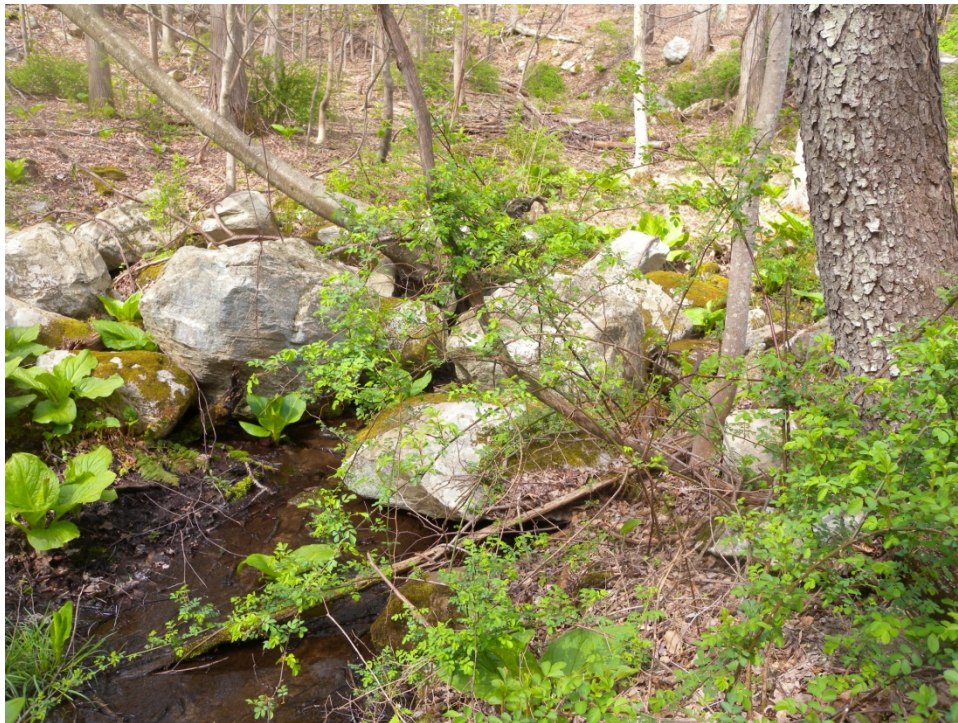
Photo 6 - EOH-07 Seepage near Right Abutment

At right side of dam near right abutment, about 30 feet of
the slope has dumped boulders mixed with dry grass and
vegetative growth. At toe of this portion of the slope
significant seepage was occurring.

It was reported that this portion of slope had
sloughed in past; and temporary fix was done.

- f) The seepage at the toe of the rock filled downstream slope near the right abutment dam contact should be monitored.

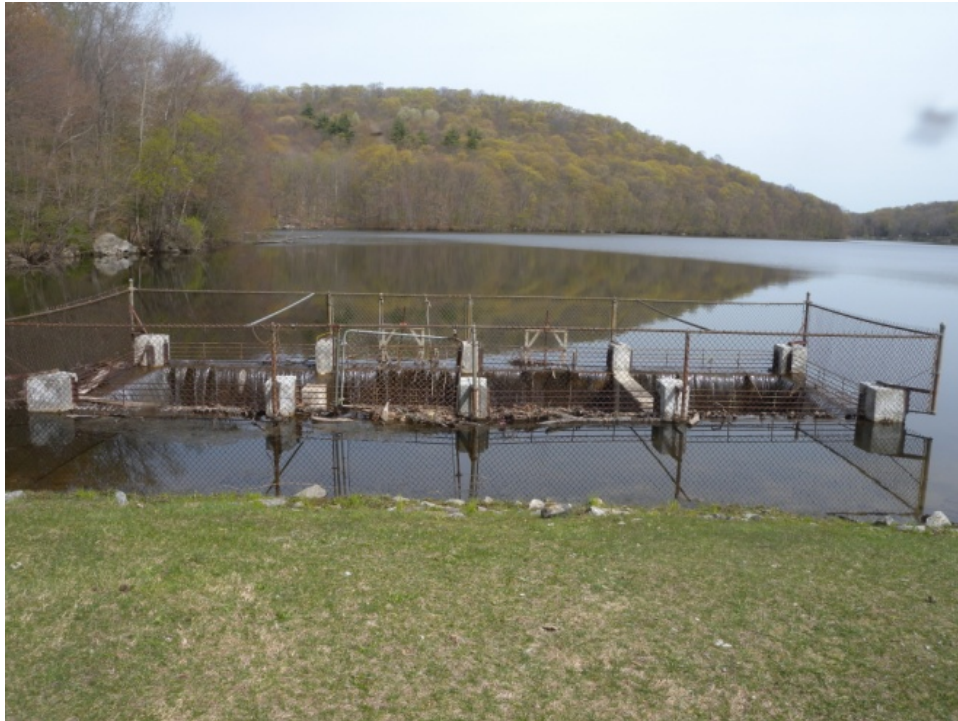
Photo 7 - EOH-07 Spillway

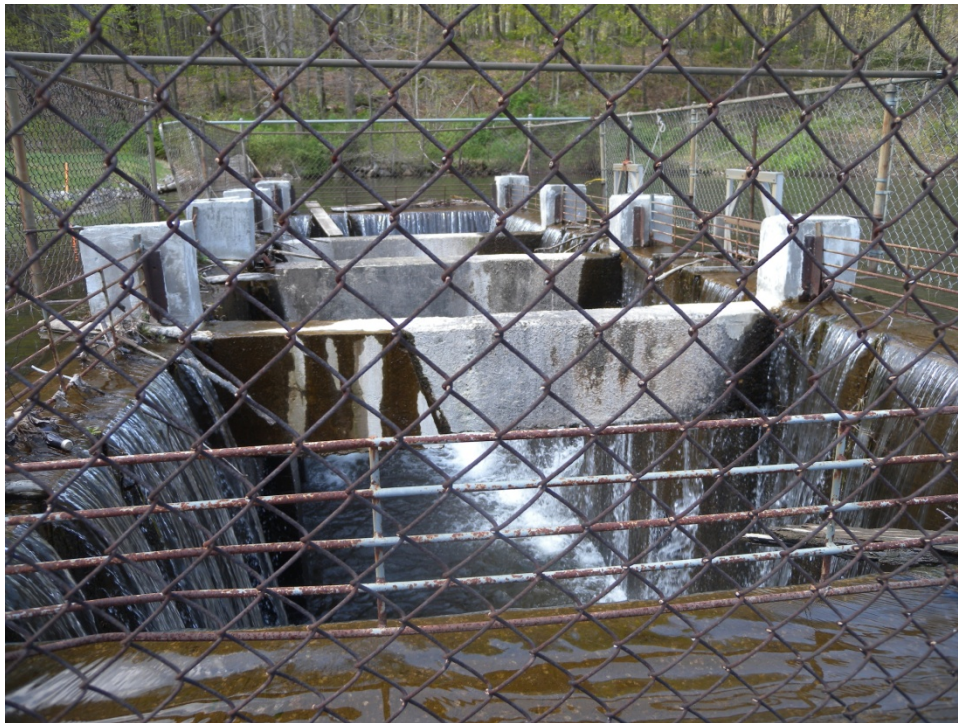
Photo 8 - EOH-07 Drop Inlet Spillway

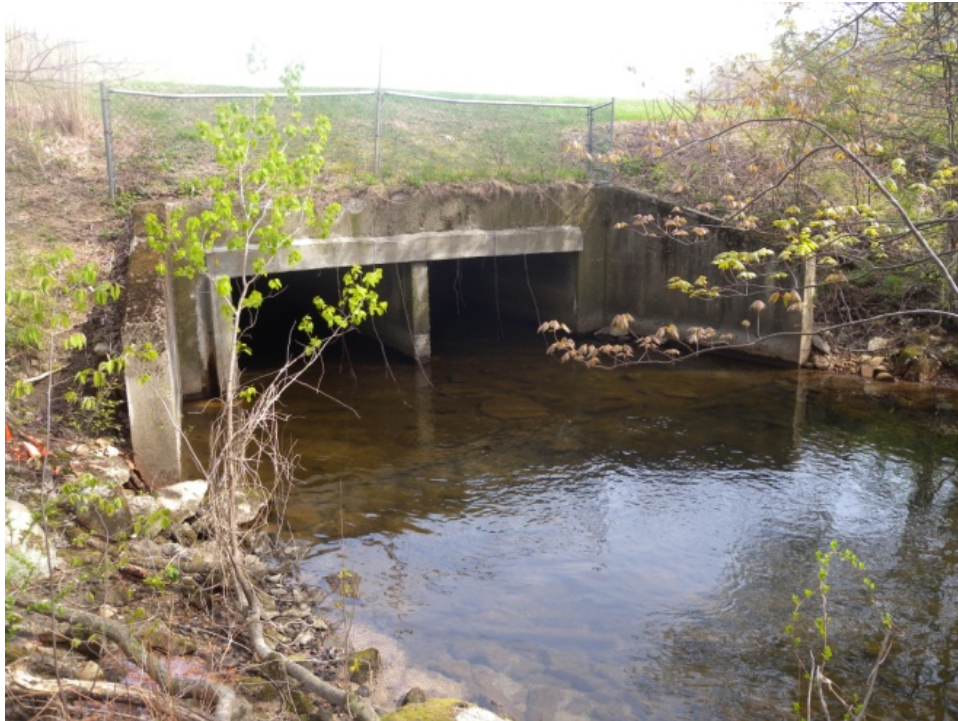
The spillway outlet concrete structure located at the downstream slope of the embankment is in good condition, except for minor erosion at the bottom surfaces of both downstream training walls (Photo 9). The discharge from the downstream outlet structure flows into a natural channel.

Photo 9 - EOH-07 Spillway Discharge Outlet

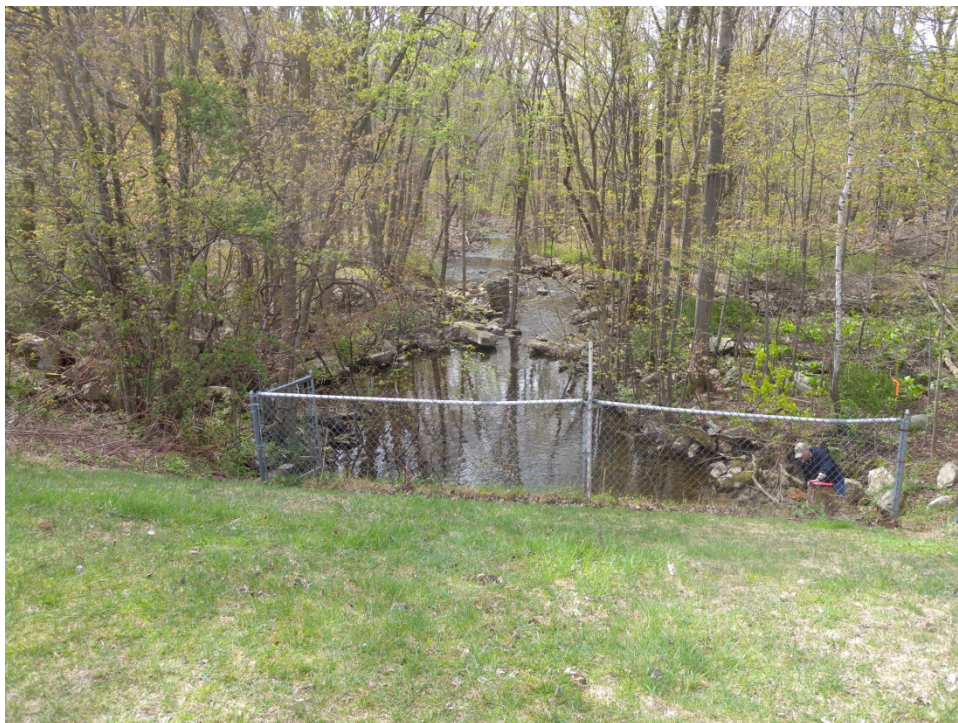
Within 100 feet from the spillway outlet, there are remnants of the abutment walls of an old bridge crossing the Leetown Brook (Photo 10); the abutments have been washed away, the deck is missing and the abutment walls are in poor structural conditions.

Photo 10 - EOH-07 Downstream Channel with Bridge Remnants
