Seven Hills Lake Dam Presentation

February 24, 2011

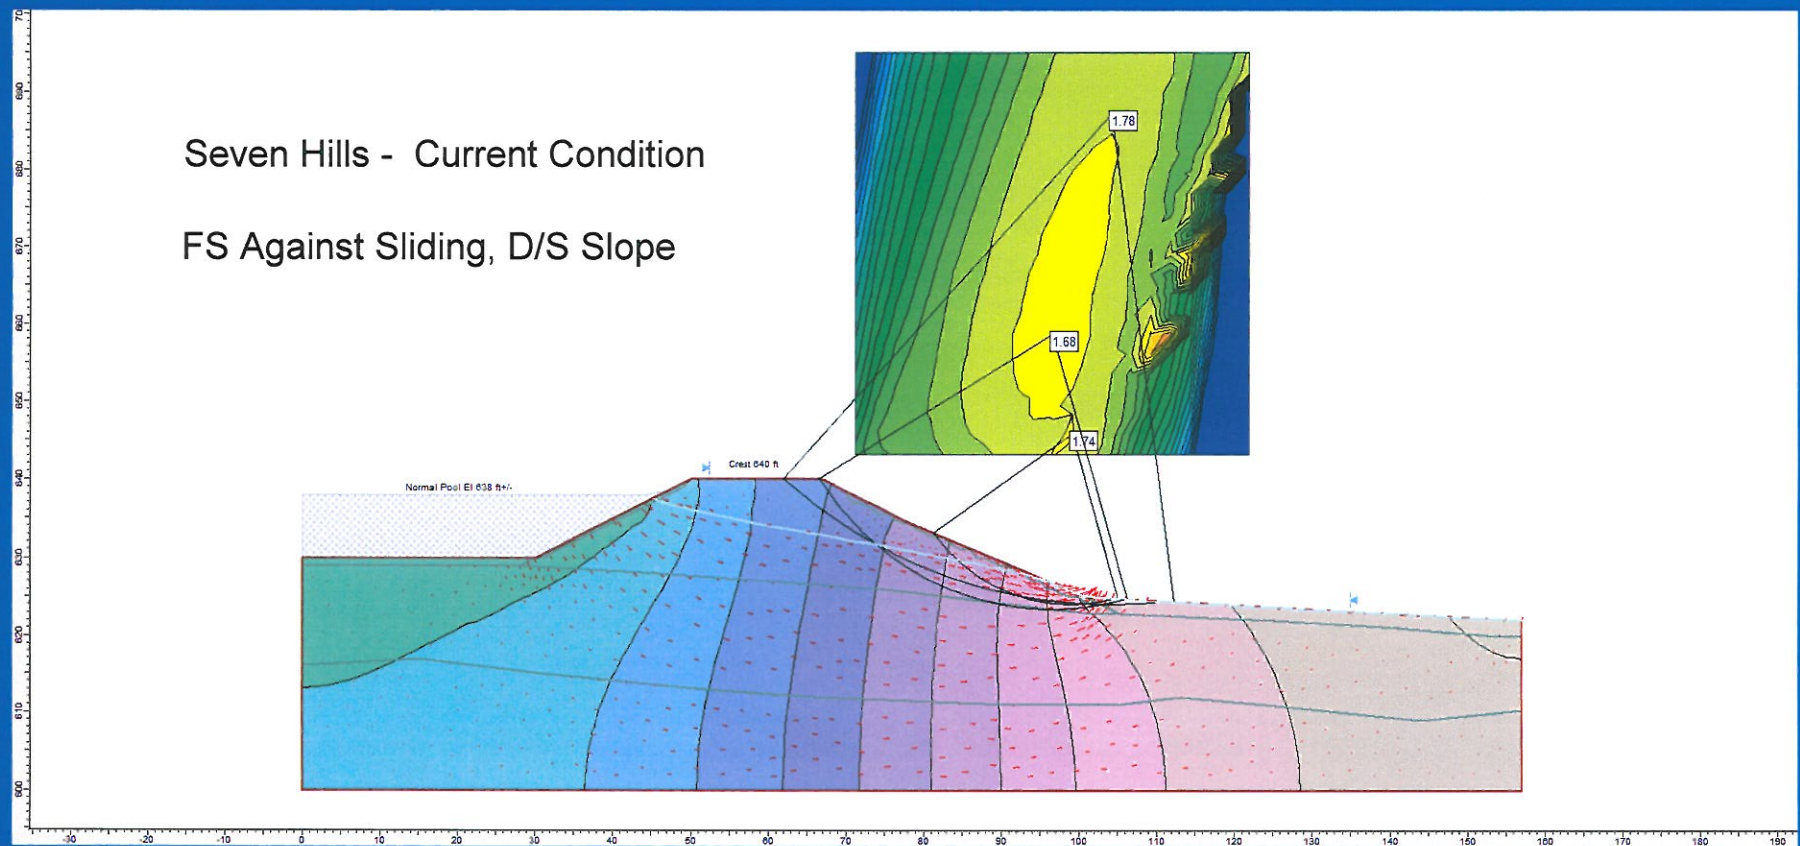
- Generally dam is in good condition
- Dam is stable - Steady Seepage Factor of Safety = 1.68

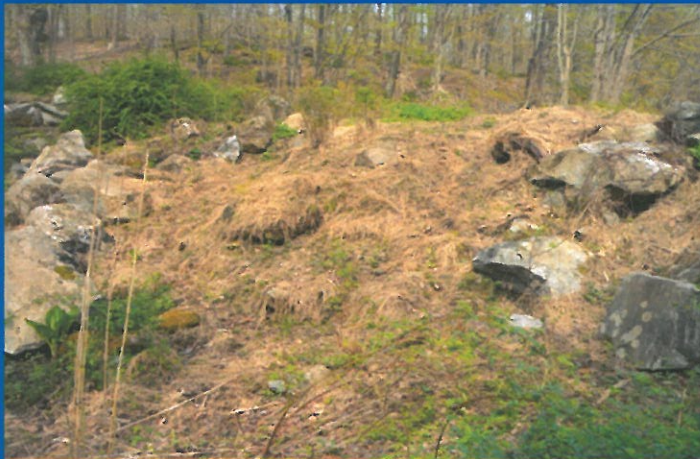
Indications of overtopping at right of spillway

Issue	Proposed Remedial Work
Overtopping of dam	Increase spillway capacity (see later)
Seepage at downstream toe of dam	For minor foundation seepage: -Place filter material at seepage areas For seepage through dam: -Reconstruct dam section
Erosion at Spillway Culvert Headwall	Place rip-rap at eroded areas

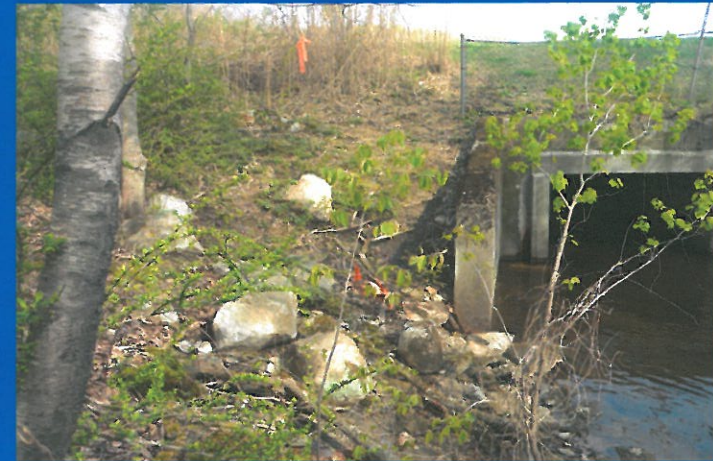
Erosion at spillway culvert outlet walls

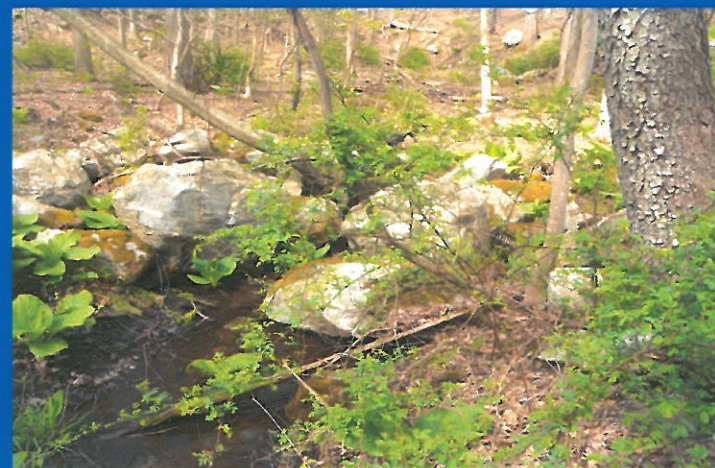
Seepage near right abutment

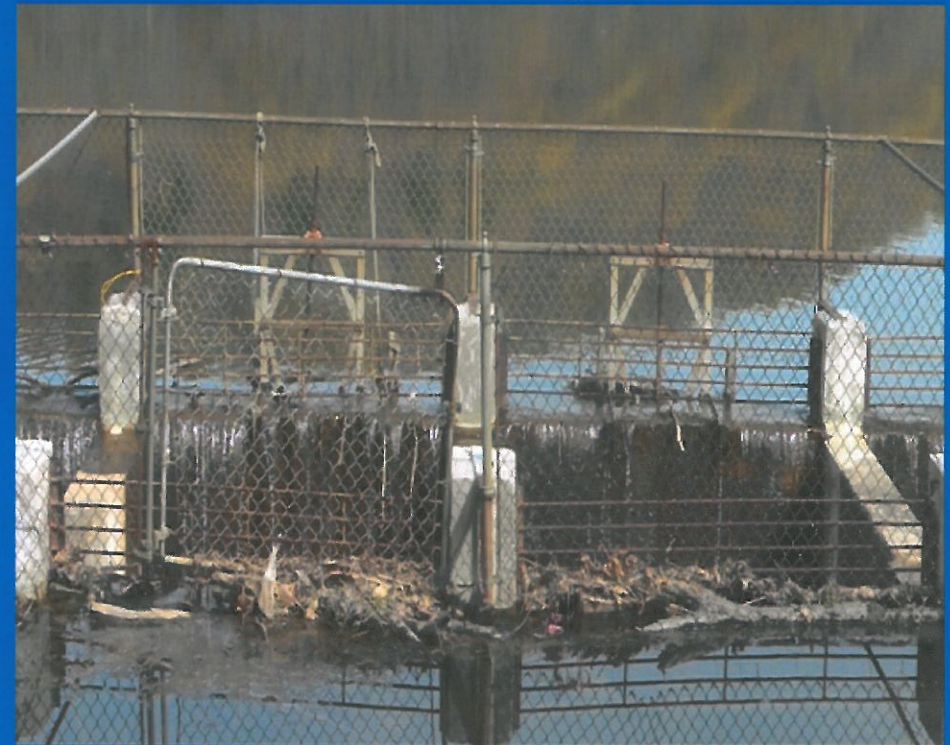
Note misaligned gate stem

- Issues
 - Condition of gates unknown
 - Operating stem out of alignment
- Remedial Measures
 - Replace gates, including stems and lifting frames
 - This will require emptying the reservoir
