Re: Seven Hills Lake Dam

**CONTRACT EE-DSGN3
Small Dams Contract Development**

**Assessment Report for
Seven Hills Lake Dam
Eastern Operations Division
NYSDEC ID# 213-2531**

October 2011

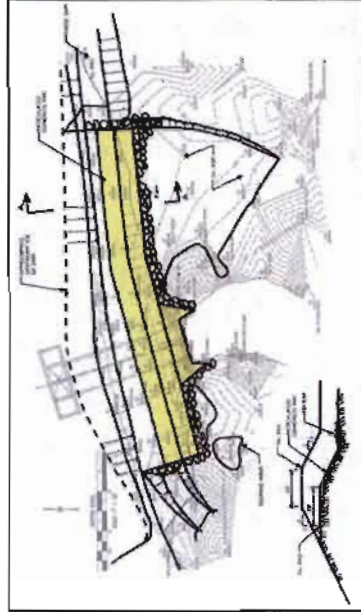
Seven Hills Dam – Adding Auxiliary Overflow Spillway

Several options were examined to address the major issue of inadequate spillway capacity. The most cost effective solution was determined to be the addition of an auxiliary overflow spillway set along most of the dam crest, using articulated concrete block mats to protect the dam fill from erosion.

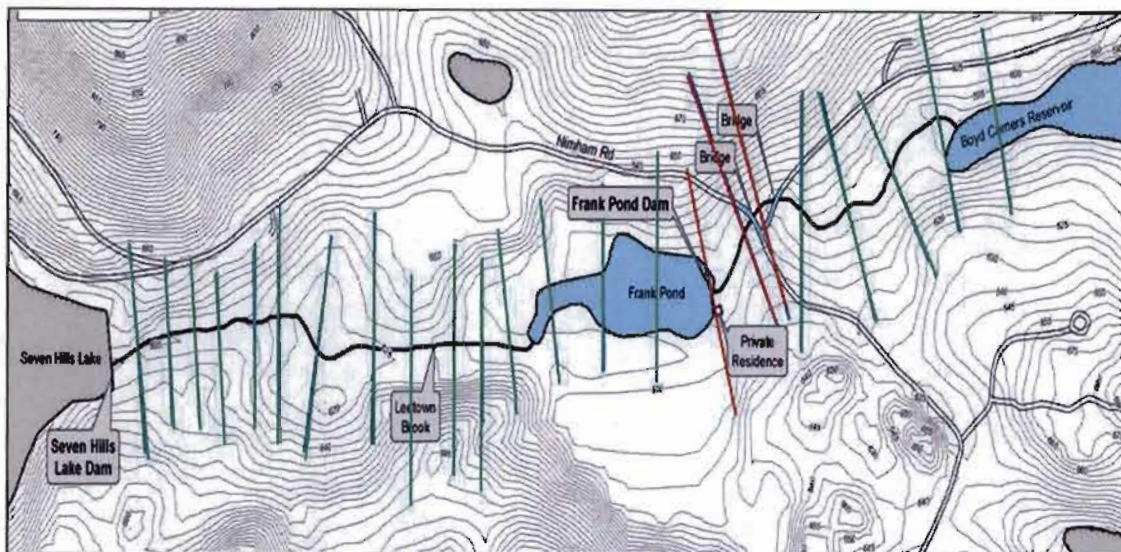
Figure 3-1: Seven Hills Lake Dam – HEC-RAS Downstream Cross Sections

The downstream area between Seven Hills Lake Dam and Frank Pond Dam was modeled using the HEC-RAS Software and was represented as a series of sections. The contour maps produced for the inspection reports were used to develop these sections. Typically, a cross section was taken every 50 feet (see Figure 3-1).

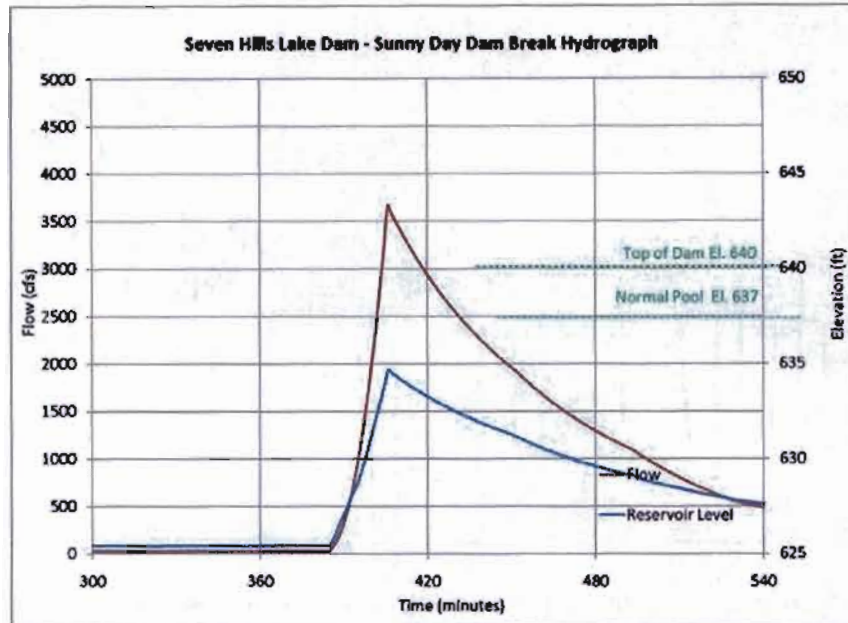
Figure 3-2: Seven Hills Lake Dam – Sunny Day Dam Break Hydrograph

Figures 3-2 and 3-3 present the flow and reservoir stage hydrographs at Seven Hills Lake Dam and Frank Pond Dam, respectively, during a Sunny Day Dam Break at Seven Hills. Figure 3-3 shows that during the Sunny Day Dam break at Seven Hills Lake Dam, the water level at Frank Pond Dam just barely rises to the elevation of the house.

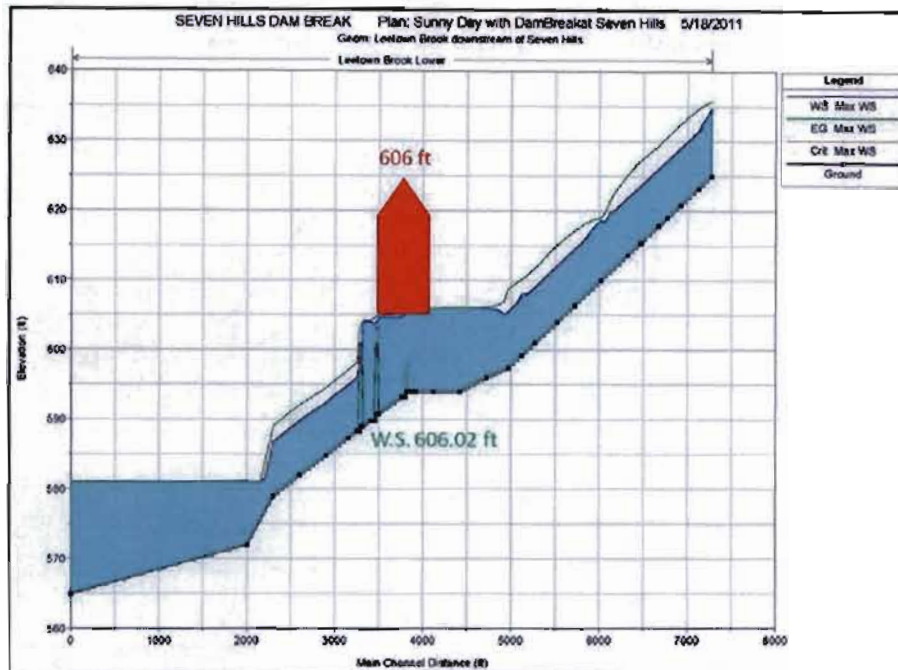
Figure 3-4: Downstream Profile during Sunny Day Breach at Seven Hills Lake Dam

Figure 3-4 shows the downstream flow profile as a result of a Sunny Day Dam Break at the Seven Hills Lake Dam.

It should be noted that there is no significant flooding at the house located near Frank Pond.

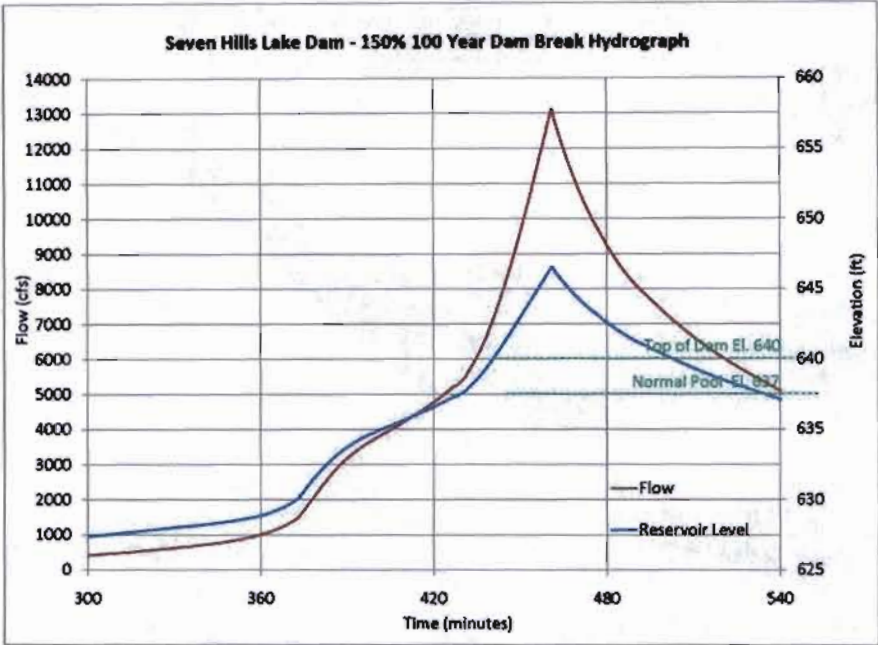
Figure 3-5: Seven Hills Lake Dam – 150% of the 100-Year Dam Break Hydrograph

Figures 3-5 and 3-6 present the flow and reservoir stage hydrographs at Seven Hills Lake Dam and Frank Pond Dam, respectively, during the SDF Dam Break at Seven Hills. Figure 3-6 shows that during the SDF Dam break at Seven Hills Lake Dam, the water level at Frank Pond Dam rises approximately 4 feet over the ground floor level of the house. Therefore, a SDF Dam Break at Seven Hills Lake Dam would cause significant flooding at Frank Pond and the nearby residence.

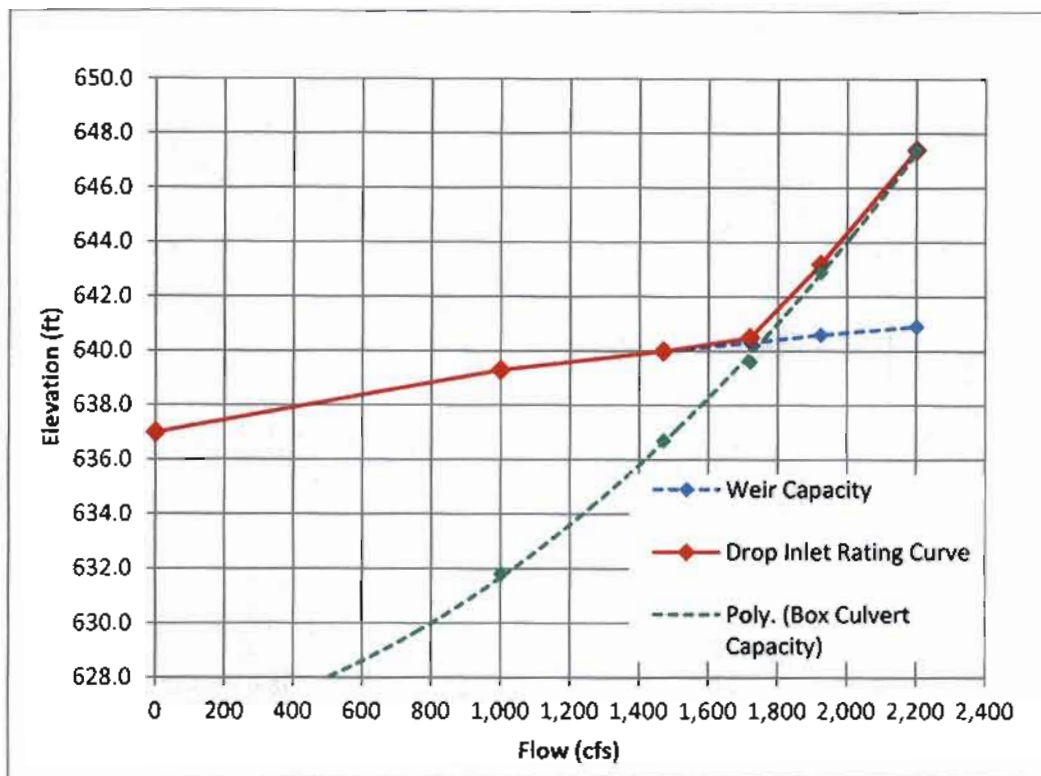
Figure 4-2: Seven Hills Lake Dam - Spillway Rating Curve

The spillway capacity with the reservoir at the top of the dam at El 640 (i.e. with no freeboard) is approximately 1,500 cfs.

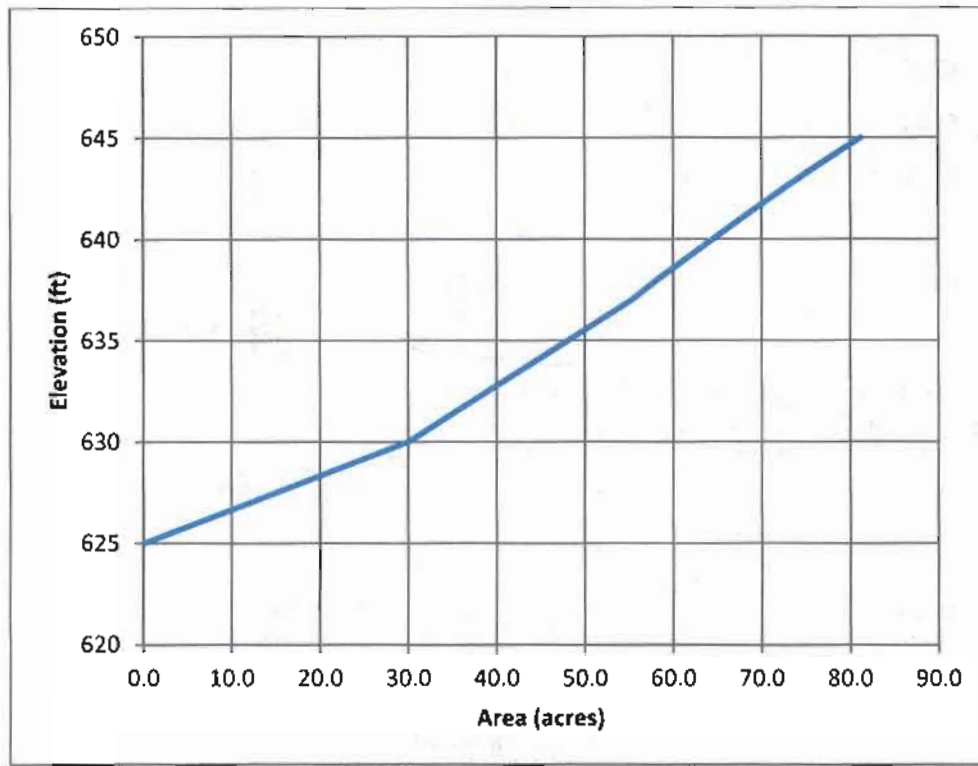
Figure 4-3: Seven Hills Lake Dam - Reservoir Area Curve

The reservoir volume at normal pool level (El 637) is estimated to be 369 acre-feet. Maximum impoundment volume, assuming the reservoir is at the top of the dam (El 640), is estimated at 548 acre-feet.

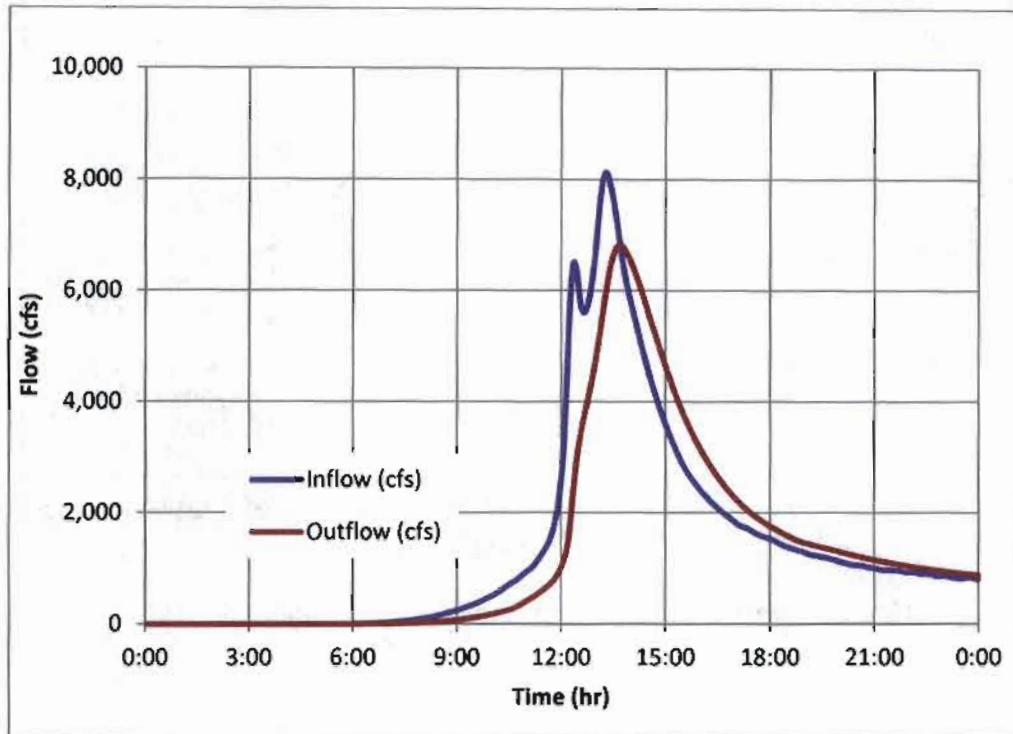
Figure 4-2: Seven Hills Lake Dam - Spillway Design Flood Routing

- 150% of 100-yr, 24hour storm:
 - Peak Outflow: 6,820cfs
 - Maximum Water Surface Elev.: 643.7 ft

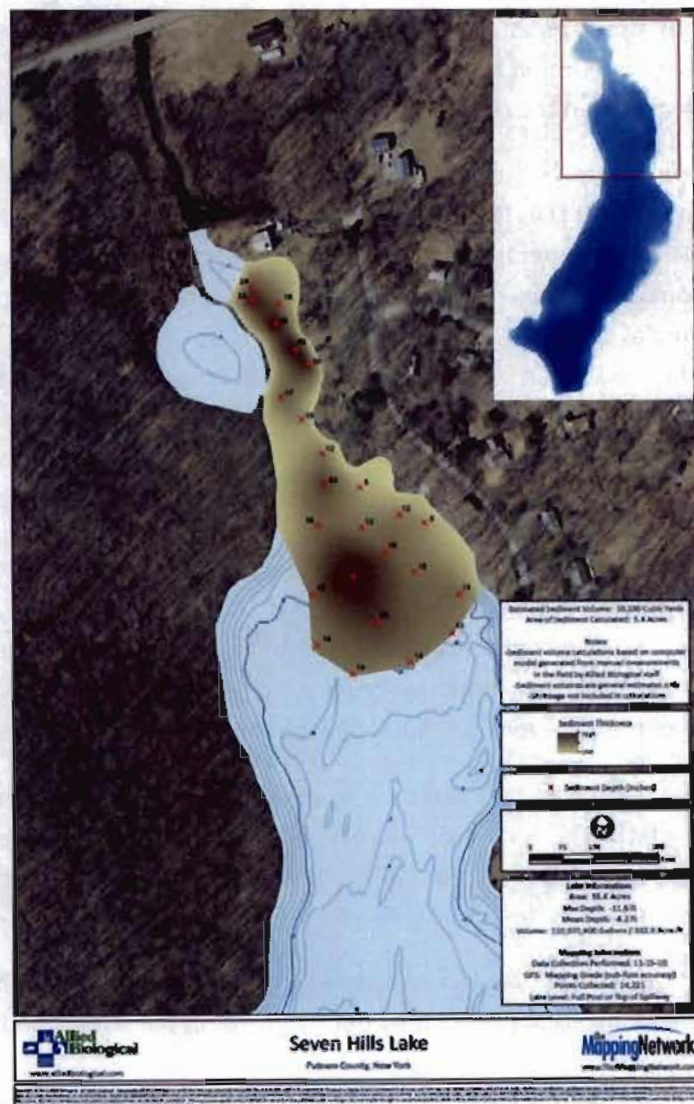
Figure 7-1: Sediment Depths in Seven Hills Reservoir

The Seven Hills Residents Association has commissioned surveys of sediment deposits at the head of Seven Hills Reservoir. Figure 7-1 shows the sediment delta at the head of Seven Hills Reservoir. This sediment has been carried by the stream from the 3.65 square miles of catchment area upstream of the reservoir. The volume of the sediment delta has been estimated as 10,100 cubic yards. Seven Hills Lake Dam was completed in 1957, giving a 53 year operating life to the date of the sediment survey. Thus, the average sediment yield from the stream amounts to 60 tons/square miles/year. This is well within the "Rule of Thumb" for dams in the North East, which gives sediment yields in the range of 20 to 90 tons/square mile/year.
