CONTRACT EE-DSGN3

Small Dams Contract Development Technical Memorandum 2-3 EOH Dam Inspection Reports

Eastern Operations Division:
EOH-07 – Seven Hills Lake Dam

October 2010

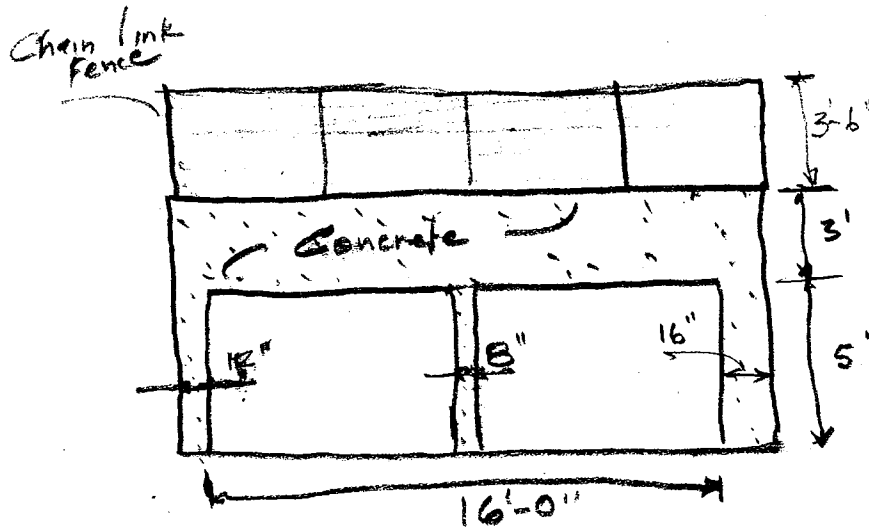
SPILLWAY CULVERT
 DOWNSTREAM HEAD WALL
 NTS

The spillway outlet concrete structure located at the downstream slope of the embankment is in good condition, except for minor erosion at the bottom surfaces of both downstream training walls (Photo 9). The discharge from the downstream outlet structure flows into a natural channel.
